# Crash Tests of Vehicles – Selected Experiments and Analysis

## 2 HEAD-ON COLLISION OF A PASSENGER CAR ŠKODA FABIA 1.2 HTP WITH A BARRIER

## 3 HEAD-ON COLLISION OF A PASSENGER CAR ŠKODA 120 AND NISSAN MAXIMA WITH A BARRIER

#### 4 HEAD-ON COLLISION OF A PASSENGER CAR RENAULT 5 GTD WITH A BARRIER

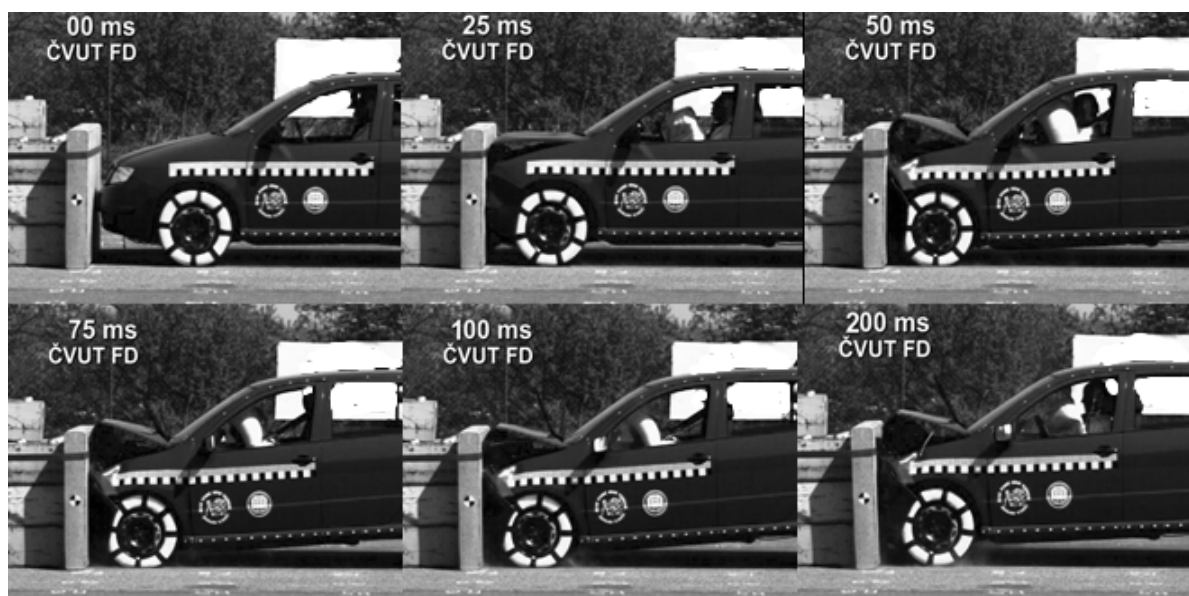
Fluid leaks: coolant leaked, leakage of a small amount of fuel from damaged fuel line to injection units. Brake fluid, engine and gear oil without leaking.

Wheelbase: unchanged - as measured by total station, a deviation of  $\pm 2$  mm from original state.

Wheels: tires undamaged – inflated, discs (metal) undamaged.

Passenger space: airbag on the driver's position was activated. Belt pre-tensioners were activated, it was possible to unwind driver's belt, whereas passenger's belt was blocked. The steering wheel remained without visible deformation; displacement of the steering column has not been documented as the steering wheel did not move towards the interior. The position of seats remained unchanged. There was also a visible deformation of the dashboard, specifically in the area of the glove compartment in front of the passenger, where the switch box is towards driver's knees. Asymmetric gaps occurred in plastic parts of the dashboard. Foot pedals remained non-deformed and functional.

Vehicle body: deformation and damage to the hood, headlights and wipers, bumper, bumper beam, left and right front fender, including arches. There was also an occurrence of recesses at the sill of B-pillar connection and cracks in the lower corners of the windshield. Steering remained functional, but the wheel turning angle was limited.

Engine Compartment: left and right longitudinal beams were deformed in the front. The engine moved backwards and the flexible engine mounts on the right side were damaged. Gearbox suspension was deformed on the left side. Damage of radiator including fan, destruction of plastic parts and injection system suction of engine unit were identified. The engine control unit was released from its holder.

**Figure 3: Frontal impact of Škoda Fabia to rigid barrier.**

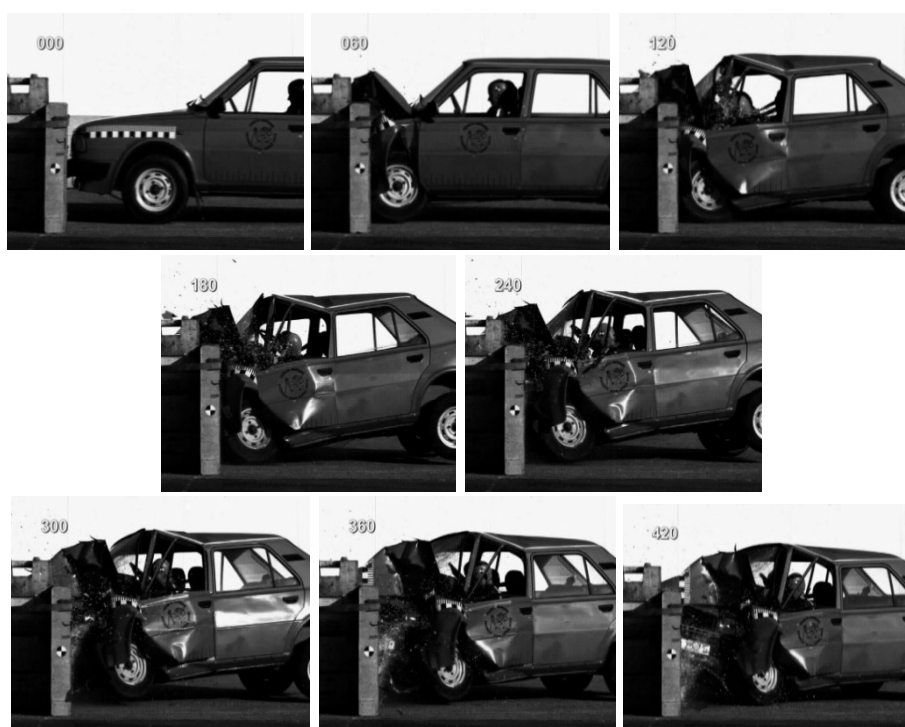
Due to the impact, the front of the car was deformed by 949 mm.

Fluid leaks: Coolant leak from damaged radiator and pipes. Other fluids such as fuel, brake fluid, engine and transmission oil remained without leakage.

Wheelbase: a major shift of front axle - deformation of housing in the vehicle body.

Wheels: tires undamaged - inflated, metal discs undamaged.

Passenger space: blocked unwinding of the seat belt coils and deformed seat belt anchorage points in the body. Large-scale deformation of the left wheel arch and the space for driver's feet (broken by floor). Deformed steering wheel rim as a result of contact with the dummy. Due to the deformation of the partition between the passenger space and the boot (in front) the dashboard frame shifted and subsequently its individual components were twisted. The plastic cover of heating in the space of front passenger's knee was torn after the contact with the dummy. There was also a significant shift in the anchorage of control pedals, pedals themselves were deformed.

Vehicle body: the following parts of the vehicle were deformed and damaged after the impact: the front boot and its suspension, headlights and indicators, front face, bumper, bumper beam, left and right front fender including arches, cracked windshield (partially withdrawn from the frame), left front doors, including rear-view mirror, left sill, breaking of the roof in line of the right A-pillar and left B-pillar, a significant shift of the partition wall between the passenger space and the front boot, change in position and the angle of the grip of the left A-pillar and roof, deformation of front axle, deformation of floor beneath the driver.

Engine Compartment (rear engine): remained without damage.

**Figure 4: Frontal impact of Škoda 120 with rigid barrier during collision.**

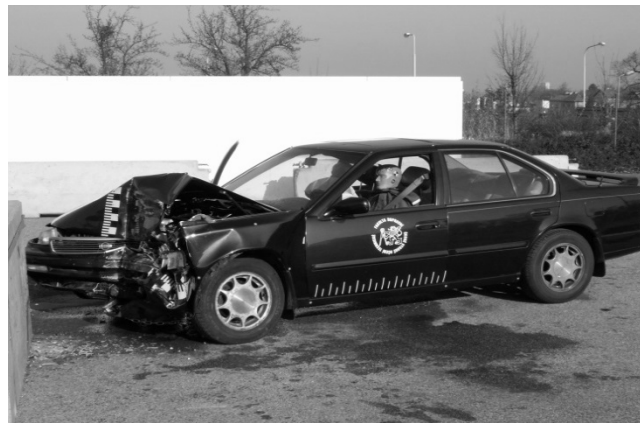
**Figure 5: Frontal impact of Nissan Maxima to rigid barrier after collision.**

The front part has been deformed by the impact of 400 mm.

Fluid leaks: Coolant leak from damaged radiator and pipelines. Transmission oil leak. Fuel, brake fluid and engine oil did not leak.

Wheelbase: the right side remained without deformation, the left side was reduced by 25 mm.

Wheels: tires undamaged - inflated, alloy wheels undamaged.

Passenger space: activated seat belt pre-tensioners, locked unwinding of seat belt recoils, activated airbag on the driver's side. The vehicle body of the passenger's space not deformed. Deformation of the cover of the glove compartment on the passenger side, and air vents at the right A-pillar on the dashboard released. The position of pedals remained unchanged and pedals were fully functional.

Vehicle body: the following parts of the vehicle were deformed or damaged after the impact: front bonnet and its suspension, headlights and indicators, left fog light, front face, bumper, bumper reinforcement, front left fender including arches. Further damage was visible at the left front wheel suspension, deformation (indentation) in connection with sheet metal roofs left B-pillar. Steering remained functional.

Engine space: deformed left longitudinal beam and the left wheel arch. Damaged radiator including ventilator. Brake booster, operating cylinder or custom brake line were not damaged.

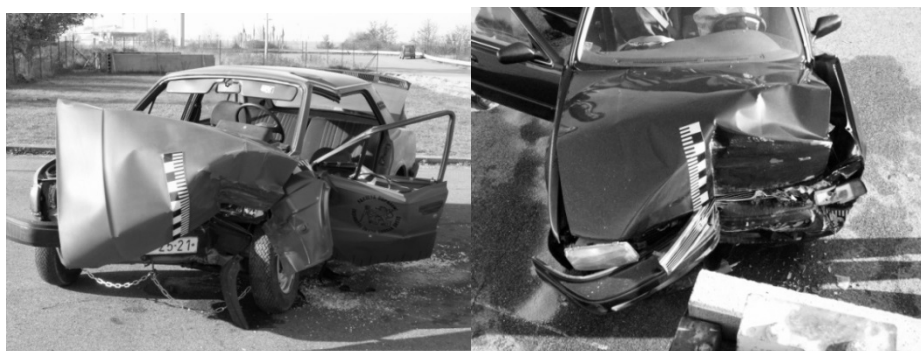
The objective of the experiment was to evaluate the safety level of tested vehicles. Škoda 120, which was approved according to ECE Regulation 12, does not provide sufficient level of passive safety. The car components collapsed and the survival space during the test was unstable. In addition, the vehicle was not equipped with modern passive safety features such as airbags and seat belt pre-tensioners. The test with Nissan Maxima showed significantly better results than the crash test with Škoda 120. This vehicle was approved by U.S. homologation methodology, which was much stricter than ECE 12. In addition, Nissan Maxima was equipped with effective passive safety components.

**Figure 6: Technical condition of vehicle Škoda 120 (left) and Nissan Maxima (right) after collision.**
