Comparison of HIC Values during Train-Car Collisions

ABSTRACT: Accident statistics show that a collision of a train with a car has a significant share of the number of traffic accidents. It also ranks among the most tragic. Three crash tests were made simulating the side impact of a railway vehicle with a car on a level crossing to monitor the biomechanics of possible injury. This study pays particular attention to head injuries. Head acceleration in all three axes was captured on a mannequin during an impact with Skoda Superb and Skoda Favorit vehicles. The most common head injury criterion (HIC) was selected as a quantitative indicator for comparison. It transpired that the contact of the head with an element of the car interior, whether or not the out-of-position occurs during the impact, plays an important role in the severity of head injuries.

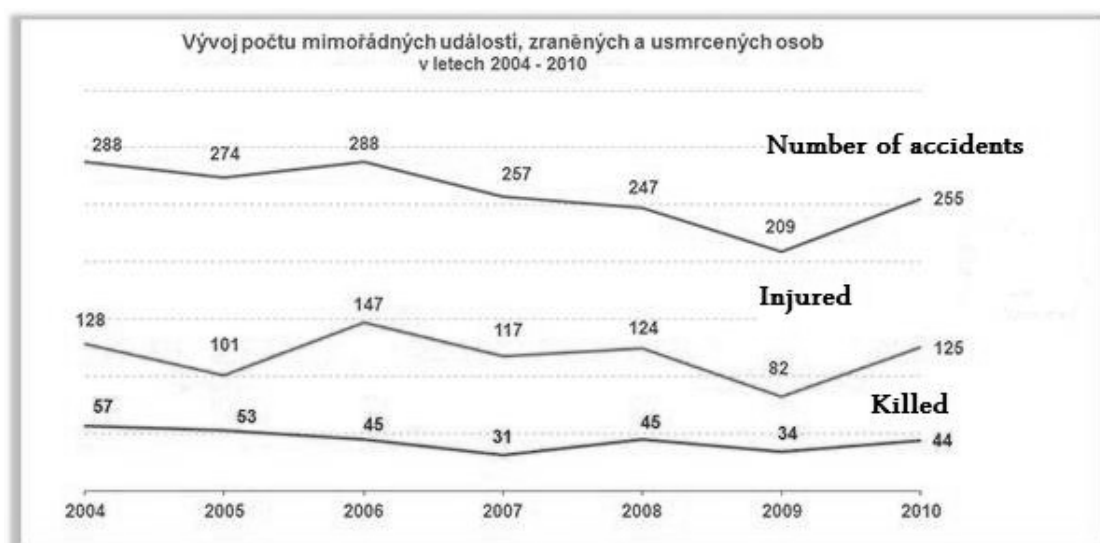
Figure 1a: Number of accidents at level crossings and deaths caused by them. Emergencies, i.e., all accidents at level crossings (including accidents involving pedestrians, cyclists, etc.) and the number of injured and killed people in the Czech Republic in 2004 to 2010 (The Railway Safety Performance in the European Union, 2010).

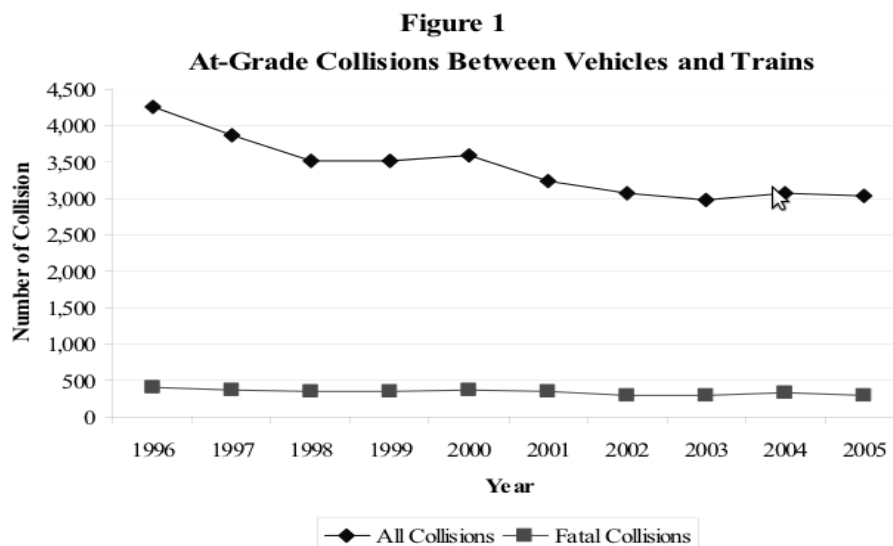
Figure 1b: Number of collisions of vehicles and trains at level crossings and deaths caused by them in the U.S. between 1996 and 2000 (Raub, 2007).

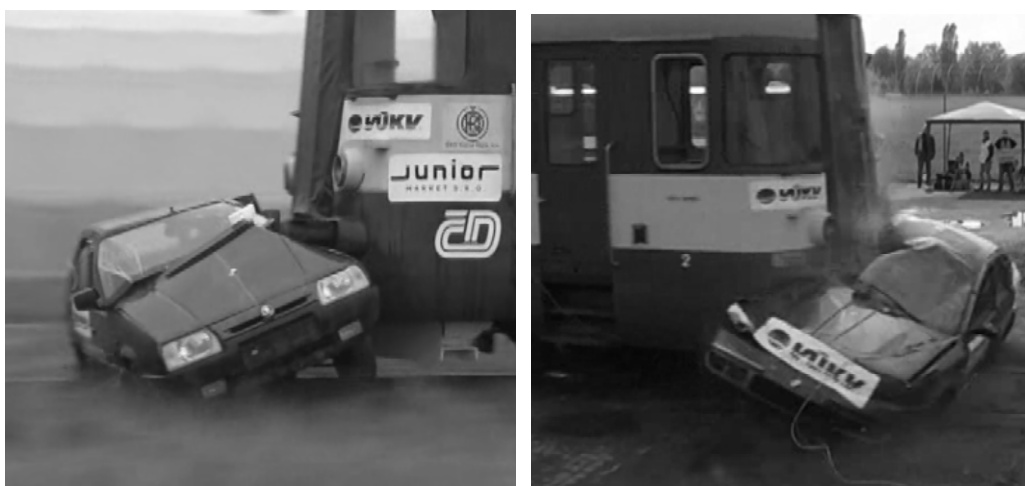
Figure 2: Detail of impact of the rail vehicle with the Skoda Favorit (left) and the Skoda Superb (right).

Three crash tests were carried out within a day (average temperature, cloudy, without precipitation). The instigator of the impact was a rail vehicle - motor number 850, 50.5 t in weight. The rail vehicle has two standard plate bumpers in the front, 53.5 cm in front of the body. The subjects of the impact were 2 Skoda Favorit vehicles (green and white) with an operating curb weight of 915 kg, produced from 1988 onwards, and 1 Skoda Superb vehicle of operating curb weight 1530 kg, produced in 2001. All the cars were left-hand drive. The estimated impact speed was 30 km/h for the Skoda Favorit vehicles and 50 km/h for the Skoda Superb vehicle. The cars were at rest, perpendicular to the direction of travel of the rail vehicle and the point of impact was in center of the vehicle, to the left side of Favorit, to the right side of Superb (see Fig. 2).

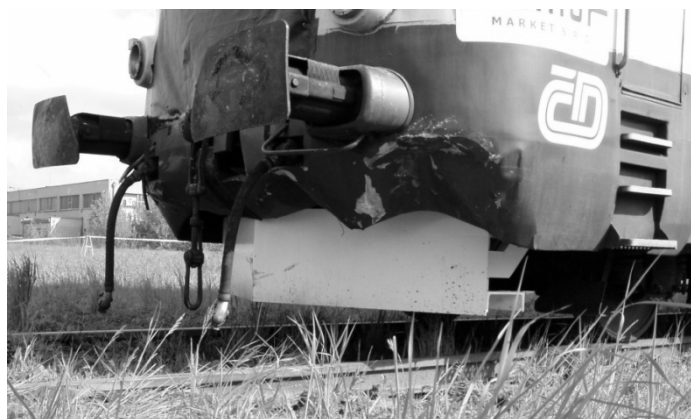
Figure 3: Detail of the front of the railway vehicle for the crash into a green Skoda Favorit and Superb.

The rail vehicle was additionally equipped with a swept-bumper in front of the buffers during the impact with the green Skoda Superb and Favorit (see Fig. 3).

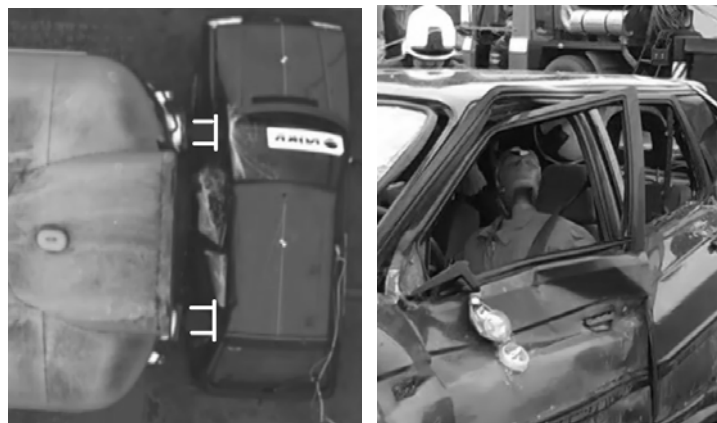
Figure 4: Detail of primary contact of the rail vehicle with the green Skoda Favorit (left), final position of a dummy after the crash test (right).

The real impact speed of the rail vehicle during the crash test with the green Favorit was 29.3 km/h. Initial contact was between the plate bumpers and the A and C pillars of the car (Fig. 4). Contact of the rail vehicle body with the car door space followed. No contact between the car and the plow installed on the rail vehicle was registered from an analysis of the video. The dummy was slightly diverted from the point of impact afterwards, shoulder leaning against the side of the passenger seat (Fig. 4).

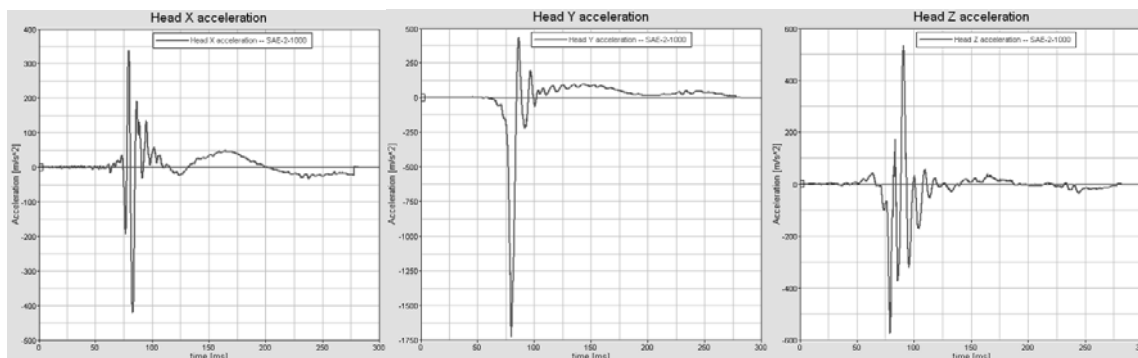
Figure 5: Recording of the accelerometers in X, Y, Z axes (left) after SAE-2-1000 filter.

Data from the accelerometer (see Fig. 5) was filtered using CFC 1000 filter after importing into the HyperGraph according to the methodology of Euro NCAP. CFC 1000 is characterized by the following parameters: 3 dB limit frequency is 1650 Hz, stop damping is -40 dB and sampling frequency is at least 10 kHz.

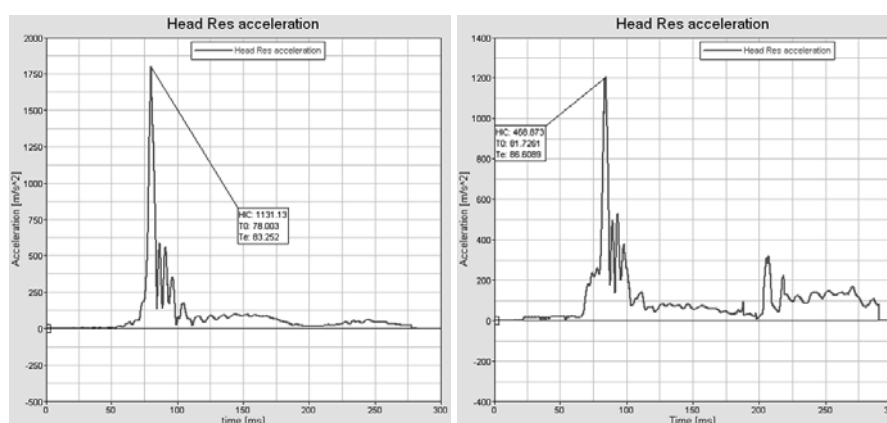
Figure 6: The resulting acceleration of the head for the green Favorit (left) and white Favorit (right).

Furthermore, the values in each axis were converted to a final value of the acceleration of the head (Fig. 6) and the value of HIC = 1131 was calculated.

The impact speed in the crash test with the white Favorit was 25.3 km/h. The initial contact was again with the plate bumpers into the A and C pillar of the car. In this case, the addition of the plow was not used. The dummy had been diverted from the point of impact at an angle of approximately 45 degrees, elbow propped on the seat part of the passenger seat. The values of the accelerometer for individual directions were filtered by CFC 1000 and converted to a final value of the acceleration with the calculation of HIC = 469 (Fig. 6).

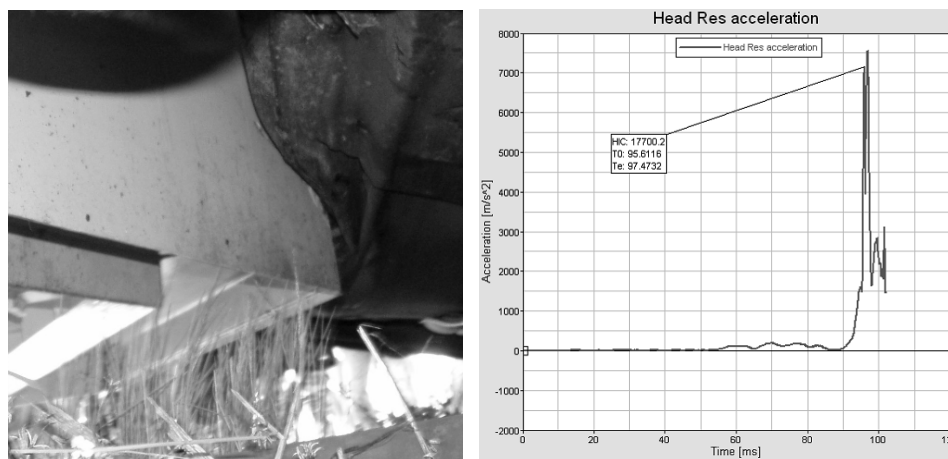
Figure 7: Detail of the rail vehicle plow contact with the car threshold (left) and the resulting acceleration of the head for Superb (right).

The impact speed for the Superb was 47.5 km/h. The impact was directed onto the passenger side, one plate of the bumper to the A-pillar and the second into the glass space above the luggage compartment before the C-pillar. The rail vehicle was equipped with an additional plow and the contact of the plow with the vehicle body was clearly visible (see Fig. 7). The values of the accelerometer were filtered by CFC 1000, converted to the final value and value of HIC = 17,700 was calculated (Fig. 7).

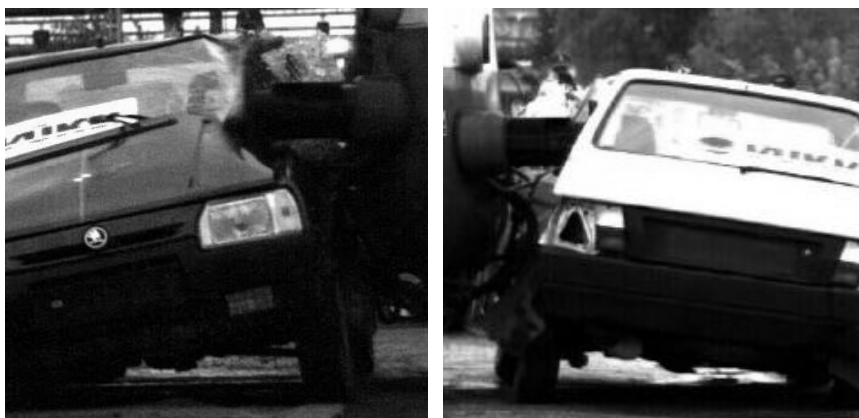
Figure 8: Contact of the head with the B-pillar, green Favorit, 75ms time from initial contact (left) and head contact with the B-pillar, white Favorit, time 85 ms from the initial contact (right).

According to the results of the accelerometers in each axis of the Skoda Favorit we can assume that there was no "hard" contact between the interior element and head of the dummy when out of position. The head hit the B-pillar of the vehicle (see Fig. 8). Due to the identical configuration of impact the size of HIC can be compared. The impact with the green Favorit was not affected by the rail vehicle plow. For the green Favorit the impact speed was 29.3 km/h and $HIC = 1131$, for the white Favorit the speed was 25.3 km/h and $HIC = 469$.

The increase in impact speed by 4 km/h caused a significant increase in HIC, over 2.4 times as much, and the limit value $HIC = 1000$ was therefore exceeded.

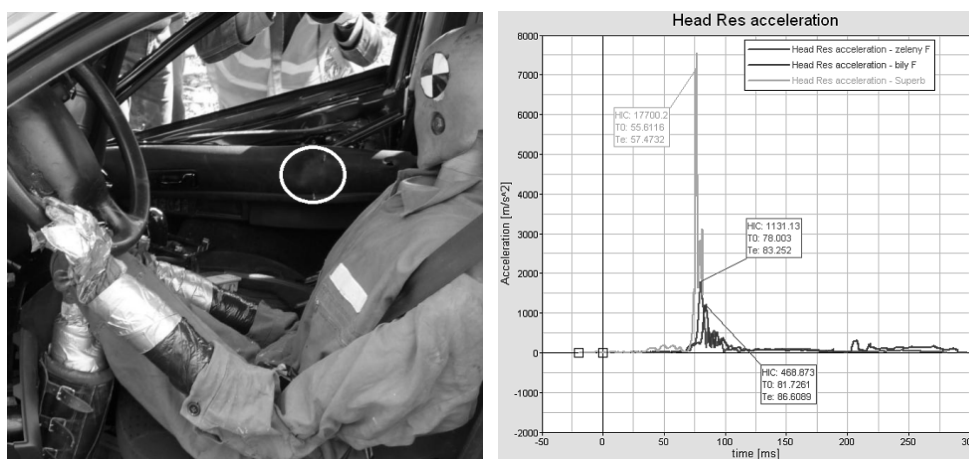
Figure 9: Probable point of contact of the head with door panel (left), and a comparison of the resulting accelerations (right).

For the Skoda Superb car the crash test came out negative. It can not be compared directly with the Favorit vehicles, because the impact speed was 47.5 km/h, i.e., 40% higher, but the $HIC = 17700$ greatly exceeded the limit value of 1000. This high value was caused by a "hard" contact with the interior element in an out-of-position during impact. Although the impact was with the side opposite that of the driver, restraint systems had not kept the dummy in a proper position and the head probably hit the inner side panel of right front door (see Fig. 9).
