Effectiveness of drainage grooves in road wearing course

M. Moravec

K. Pospíšil*

ABSTRACT: Surface drainage of road pavements with both a very low longitudinal and transversal gradient is a subject for special solutions. Drainage grooves rabbeted into the road pavement wearing course are one of them. While the costs of this kind of maintenance are not inconsiderable, the effectiveness of such a solution has not yet been independently evaluated. This paper describes experiments done in the field of assessment of the drainage grooves effectiveness.

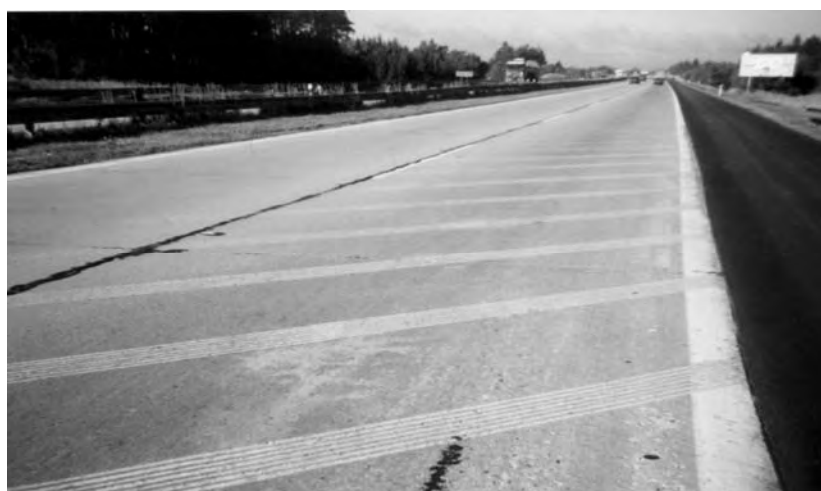
Figure 1: Grooved drain lines on a concrete motorway pavement surface

Occasionally landscape topography or technical reasons cause very low gradient of a road's vertical alignment. This causes a problem with the surface drainage of the road pavement. This situation is solved by additional measures. Pavement surface grooving is one of these. Grooves are made using slotting cutter typically over the whole width of roadway. Usually grooves create drainage lines consisting of several parallel grooves. The drain lines are repeated several times to maintain the appropriate surface drainage of road pavement surface. Figure 1 shows a typical application of grooved drain lines on a cement concrete motorway pavement.

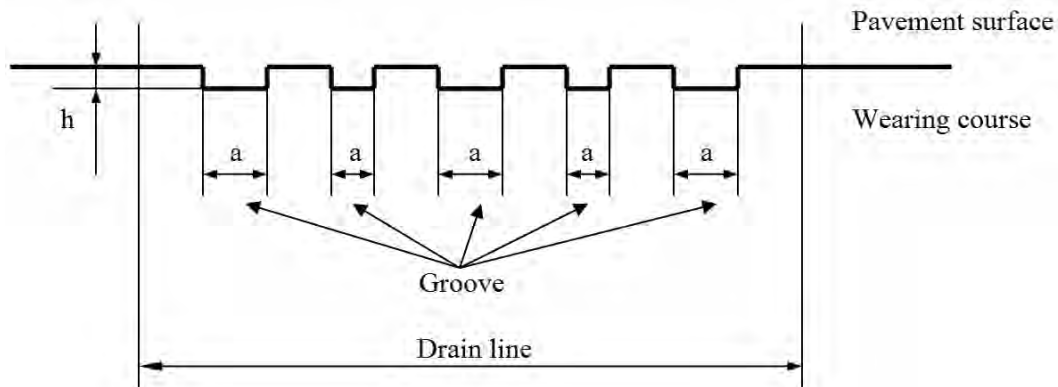
Figure 2: Schematic illustration of grooves constituting a drain line

The depth of grooves is between 1 and 8 mm, the width typically 30 mm, and the distance between neighboring grooves is from 10 to 200 mm. Schematically, the grooves and drainage line are displayed in Figure 2. Distances between neighboring drainage lines vary greatly and depend on the specific design. An angle formed with the road axis and the direction of a drainage line is usually approximately $\pm 45^\circ$.

In the case of grooves with a rectangular cross-section the hydraulic radius R can be expressed using eq. (2) with the dimensions shown in Figure 2: $R = a.h / (2h+a)$. After this modification the equation (1) obtains the form of the equation (3).

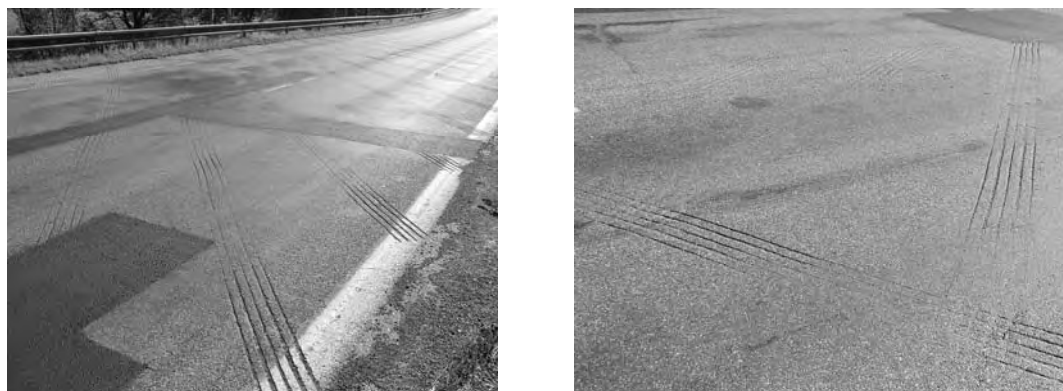
Figure 3: Grooved drainage lines on I/34 highway, exploited and deteriorated treatment

The left picture in Figure 3 shows a general view of the drainage lines' arrangement and the right picture in the figure documents the deterioration of the drainage lines caused by traffic loading.

The tests were done in two selected localities. The first one had been selected to be on a rural section of the highway I/34 between the villages Michalovice a Šmolovy, as a representative of long-term exploited treatments. Figure 3 documents the state of the drainage lines.

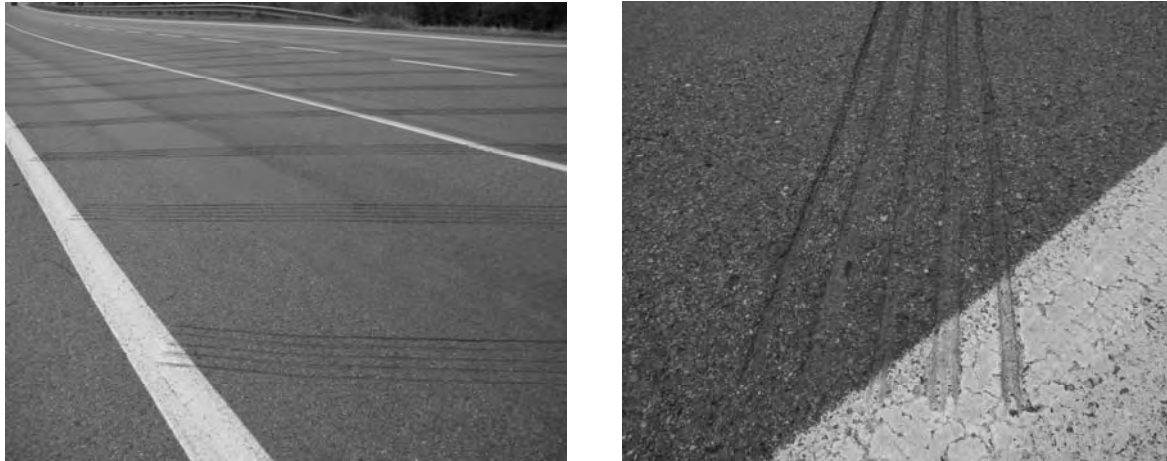
**Figure 4: Grooved drainage lines on the I/35 highway, recently established treatment**

The second locality of interest is a rural section of the highway I/35 between the village Hřebeč and town Moravská Třebová. This locality is representative of the recently established treatments. Figure 4 displays the status of the treatment at this locality.
