Exploring the safety level of a signalized roundabout with crossing BRT: an observational pilot, in Israel

VICTORIA GITELMAN, ANNA KORCHATOV

Transportation Research Institute, Technion City, Haifa, Israel 32000

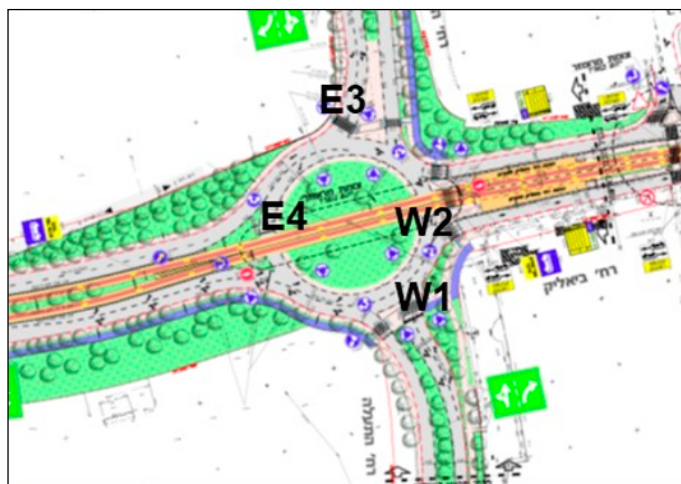
Figure 2. The four areas of video-recording in the roundabout.

- In the traffic lights' areas (zones W2 and E4, in Figure 2), when the BRT passes through the roundabout, in order to estimate the level of drivers' compliance with a red light and the risk of red-light running.

- In the entrance areas of the roundabout (zones W1 and E3, in Figure 2), under conditions with and without the BRT presence in the roundabout, in order to characterize interactions between different road users, e.g. between an incoming vehicle and vehicles traveling in the roundabout or between an incoming vehicle and a crossing pedestrian, including giving right-of-way and conflict occurrence. A conflict was identified by braking and/or change in the direction of vehicle travel (or pedestrian movement) to prevent a collision, in line with previous research (e.g. Ewing and Dumbaugh, 2009; Gitelman et al., 2017).

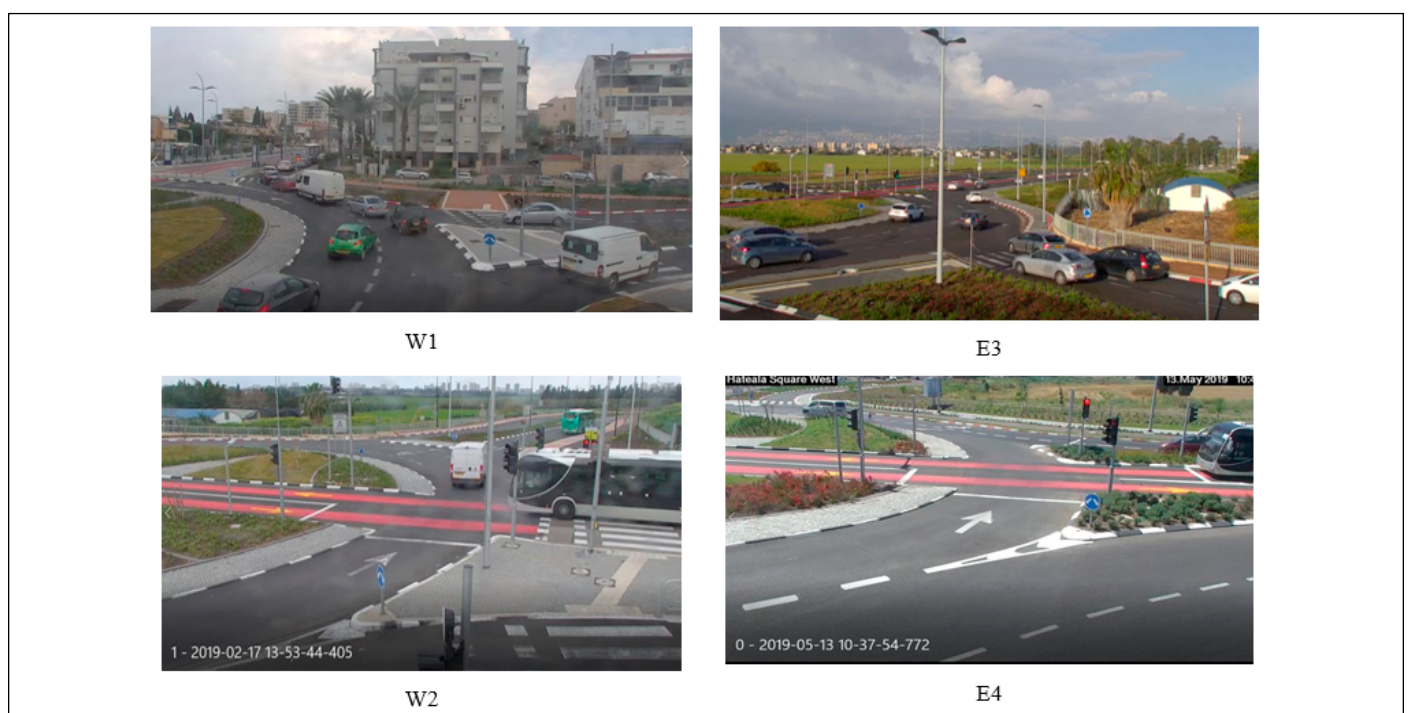
Figure 3. Pictures from the video-recording zones, in the study.

The video-records for the study purposes - the examination of road user behaviours, were collected by the traffic control center, starting from the third week of the BRT operation. The camera records were taken at four areas of the roundabout (Figure 2): two near the traffic lights in the roundabout - zones W2, E4, and two in the entrance areas - zones W1, E3. (The zone names corresponded to the camera names in the traffic control center). It should be noted that the inside and entrance roundabout zones were not identical, due to the presence of the BRT stops near W2 zone (vs. no stops near E4 zone) and a larger number of the roundabout lanes in E3 zone (two lanes for a right turn leaving the roundabout and one lane for circular traffic, vs. two lanes in total, in W1 zone). For the study purposes, the control center cameras were directed respectively: in zones W1 and E3 - towards the roundabout entrance areas; in zones W2 and E4 - towards the traffic lights' areas and the BRT crossing route (Figure 3).

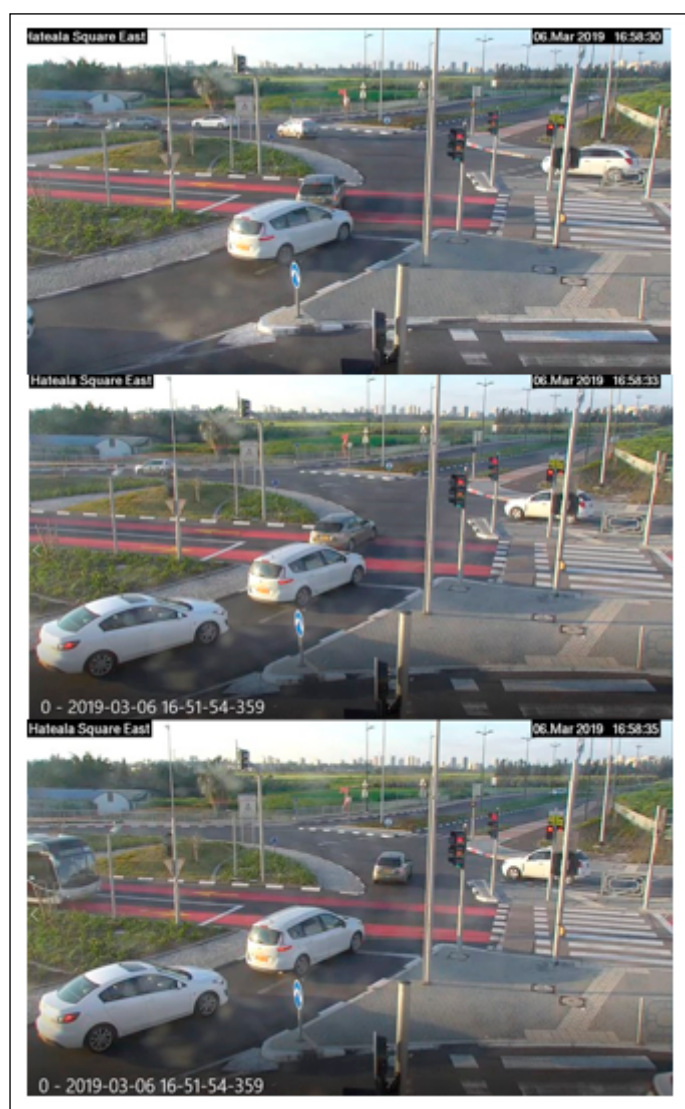
Figure 5. An example of conflict at the study site, due to in compliance with a red-light.

Furthermore, a detailed examination of the red-light running events was conducted and found that of the 28 cases observed, risk of collision was in one case only (3.6%). In this event, one vehicle passed at the red-light and stopped on the BRT route; a collision almost occurred with another vehicle that followed, but the first vehicle continued moving and cleared the BRT route before the arrival of the BRT. Figure 5 illustrates this conflict.
