# Crash Tests of Vehicles – Selected Experiments and Analysis

## 2 HEAD-ON COLLISION OF A PASSENGER CAR ŠKODA FABIA 1.2 HTP WITH A BARRIER

## 3 HEAD-ON COLLISION OF A PASSENGER CAR ŠKODA 120 AND NISSAN MAXIMA WITH A BARRIER

#### 4 HEAD-ON COLLISION OF A PASSENGER CAR RENAULT 5 GTD WITH A BARRIER

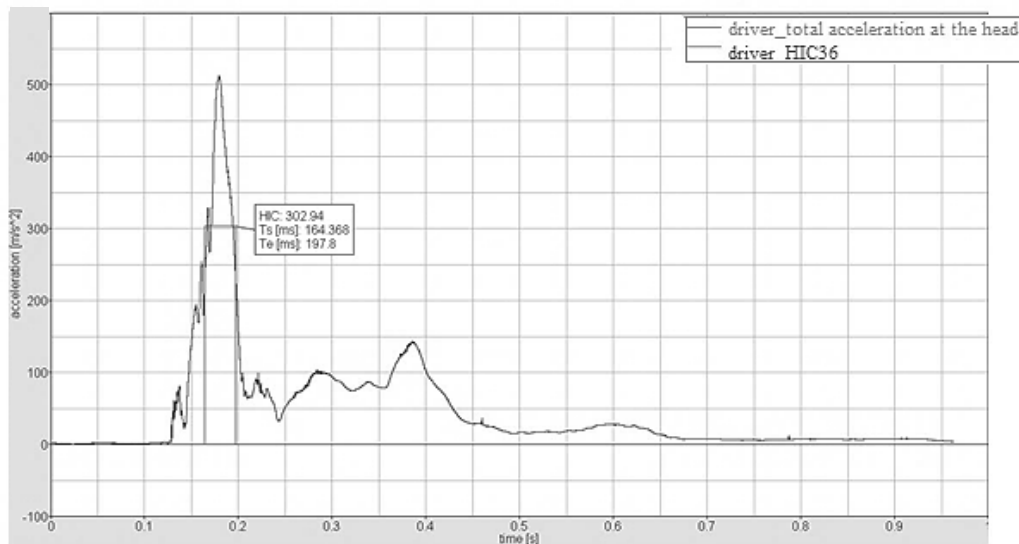
After the impact, the following head injury criterion for the crash test dummy Hybrid II was established:  $\text{HPC}_{36} = 302.94$ ;  $T_1 = 164.4 \text{ ms}$ ,  $T_2 = 197.8 \text{ ms}$  (Figure 2).

**Figure 2: Progress of total acceleration (SAE 1000) at the head of the driver's dummy and injury criteria HIC.**

After the evaluation of the test, very good safety at the front seats was found. The space for survival remained unchanged. The calculated head injury criterion was far below the threshold limit of 1000. Probable severity of the injury was at the level of AIS 1 – 2, which means skin scrapes, nose fracture, mild concussion (Viano & Olsen, 2001).

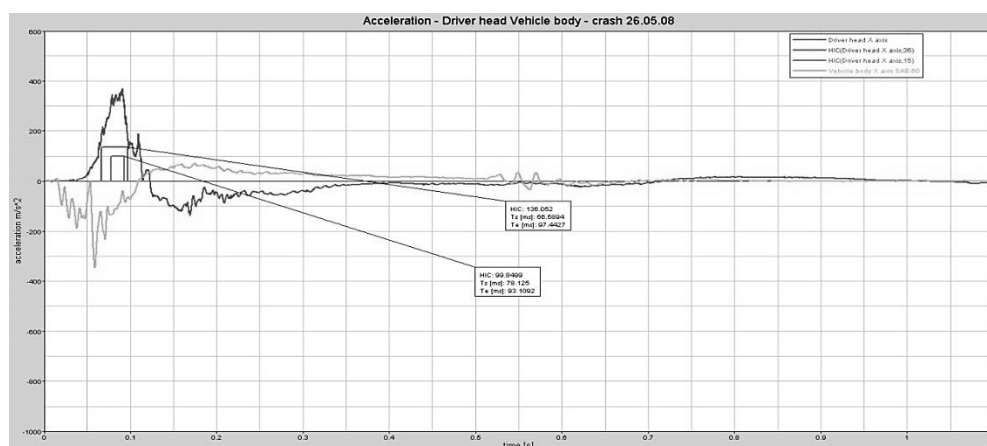
After the impact, head injury criterion for the dummy Manikin was found at  $HPC_{15} = 100$ ;  $HPC_{36} = 136$  (Figure 7). Because the driver's dummy Manikin was equipped with a simple uniaxial accelerometer, the head injury criterion is given for reference purposes and only for basic orientation, without any further evaluation of the severity of possible injuries.

**Figure 7: Progress of acceleration (SAE 1000) at the head of the driver's dummy in x direction (dark), head injury criterion HIC and acceleration of the body (SAE 1000) in x direction (light).**

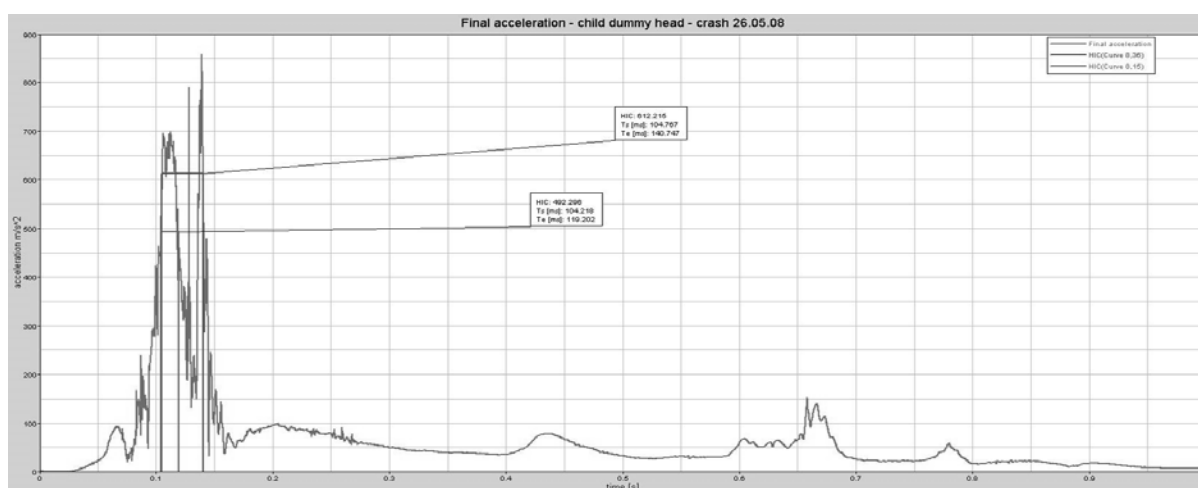
The head injury criterion of the dummy P3 in child restraint system was  $HPC_{15} = 492$ ,  $HPC_{36} = 612$  (Figure 8). It correlates with certain head injury and possible cervical spine damage, which was not observed (Dobbertin et al., 2013).

**Figure 8: Progress of total acceleration (SAE 1000) in the head of child dummy and head injury criterion HIC.**

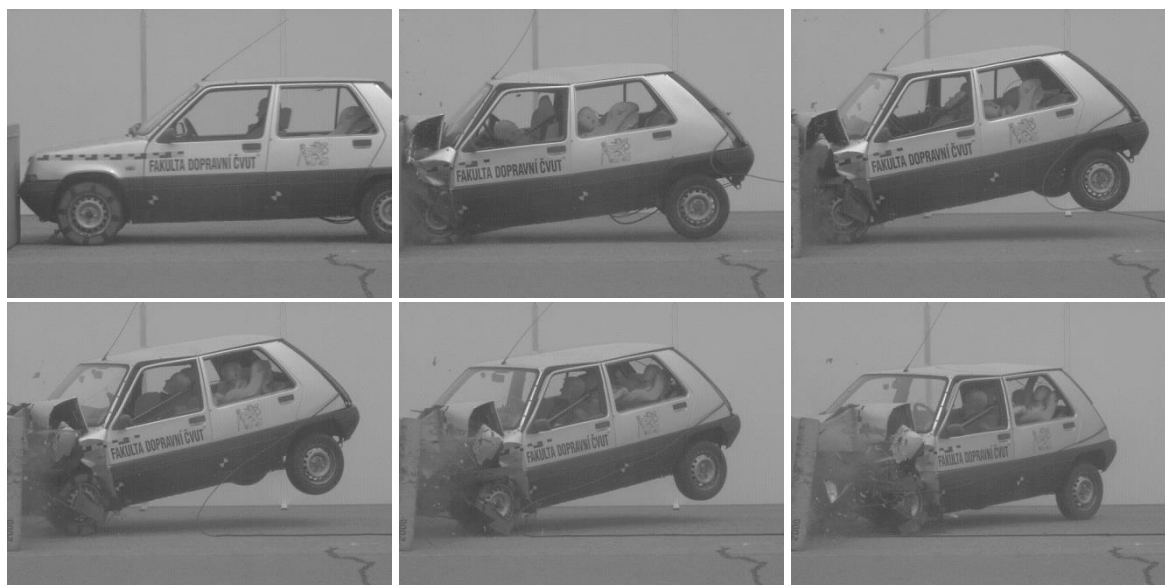
**Figure 9: Progress of total acceleration (SAE 1000) in the head of child dummy and head injury criterion HIC.**

Fluid leaks: most of the fluids were removed before the test, so, during the test, there was a leak only from oil tanks.

Body deformation and damage: bonnet, headlights and indicators, front face, bumper, bumper beam, left and right front fender including arches, sills deformation, "B" pillars, front left door and breaking of the roof.
